Intel[®] Pentium[®] III Xeon[™] Processor Specification Update

Release Date: January 2002

Order Number: 244460-032

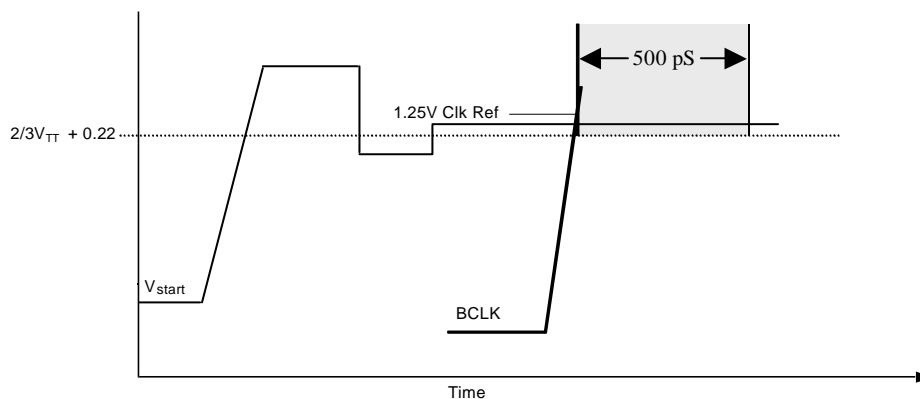
Intel has characterized the new AGTL+ AC specification for $V_{IH(MIN)}$ on the processor's RS0# signal to be: $(2/3 \cdot V_{TT}) + 0.22$ Volts within 500 picoseconds following the rising edge of BCLK crossing the 1.25-Volt threshold. See below.

Implication: The deviation from the published specification results in decreased noise margin on the RS0# processor input. This decreased noise margin has been observed to be particularly detrimental in system environments where the RS0# processor input is being driven by an I/O buffer with a pull-up device (such as a p-channel transistor) that is switched off mid-cycle. Systems that employ I/O buffers that keep the pull-up device on for the entire cycle are significantly less affected by this erratum. The reduction in noise margin may lead to the generation of BINIT# (when enabled) resulting in a system reset, otherwise this condition may lead to a system "hang" condition.

Workaround: If a system design cannot meet the specification deviation, the following areas should be carefully examined to assure that additional margin exists in order to compensate for any deficit observed with respect to the newly characterized $V_{IH(MIN)}$ specification:

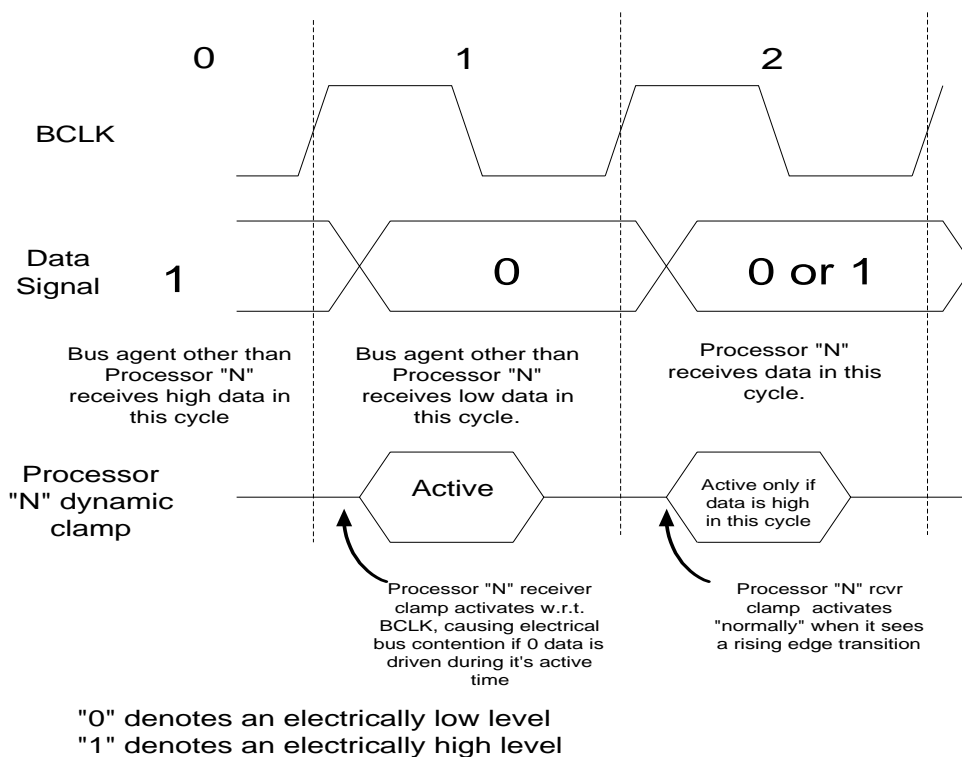
Problem: Falling edge ledge push-out and undershoot may be seen on AGTL+ data and data bus ECC signals. The AGTL+ receiver's dynamic clamp circuit activates (i.e. clamps the signal to an electrically high level) in certain cycles when data is driven to an electrically low level by another agent.

Implication: This erratum only occurs on a processor that does not receive data in that particular cycle. More specifically, this erratum only occurs when a specific processor does not receive data in the current BCLK period, but receives data in the very next period. Therefore, the processor inducing this falling edge noise (on data and data bus ECC signals) will not actually read the data in that cycle. See below for an illustration of this erratum affecting a processor denoted Processor "N". The falling edge ledges and undershoots may affect the signal quality and/or timing at agents that receive data in that cycle. Therefore, the impact of this erratum is highly dependent on system bus design.

Workaround: Evaluate system bus signal quality and timing margin at the valid receiving agent as a result of this falling edge noise. Due to dependence upon system bus design, bus layout may be evaluated to determine the need for improvements in signal quality and timing margin at the valid receiving agent as a result of this receiver-induced falling edge noise.
